TECHNICAL BULLETIN: INSULATION AND TOP PLATE GASKET ISSUES

Insulation installation and canned foam top plate gaskets have the potential for large impacts on energy savings and comfort in the home. This technical bulletin covers some frequently overlooked items that builders and raters should check when inspecting insulation and canned foam top plate gasket installation.

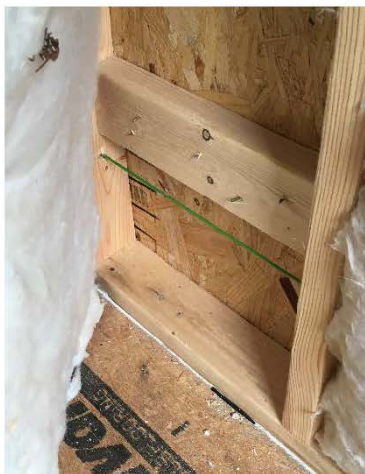
An example of termite systems and a 2x4 obstruction

1. **Electrical wires, Termite Systems, and 2x4 obstructions:** Areas approximately 1' from the bottom plate tend to have termite systems or 2x4 obstructions. In addition, electrical wires can easily be found by looking for metal plates on studs. Insulation should be cut to fit around these obstructions to comply with RESNET's grade I definition. For a video description on RESNET's grading definitions, follow this [link](#).
2. **Rolled or tucked batts:** Inspect the top and bottom of wall cavities. Often, insulators roll or fold insulation into the bottom or top of wall cavities instead of trimming insulation to fit cavities properly.
3. **Overfilled cavities:** To save time, insulators will place small pieces of batts behind wires and place a full batt over top of the wire. This does not constitute grade I installation and causes compressions and overfilling.

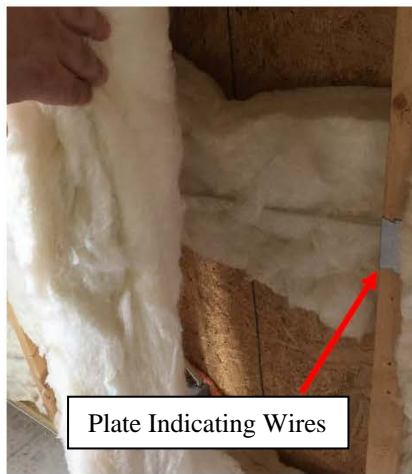
An example of an overfilled cavity with a plate highlighting the wire location

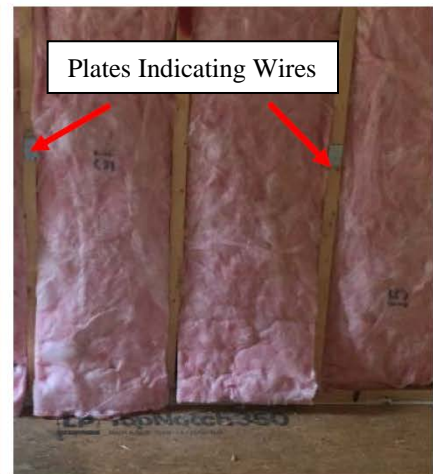
An example of batts not cut to fit wall cavities with plates showing wire locations

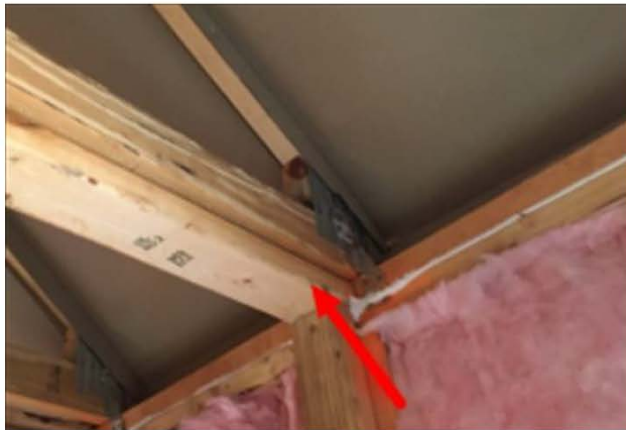
An example of top plate gasket missing on interior walls.

- **Interior vs Exterior walls:** Installers sometimes apply top plate gaskets on the exterior walls only. The interior walls can account for as much as 70% of all gaps between the drywall and top plates. The leakage that the gasket prevents is between the living space and the attic, so interior walls are just as important as exterior walls.
- **Foam location:** Its best practice to apply a ¼" bead of foam in the middle of the bottom course of the top plates. Some installers apply the foam at the seam of the top plates, which may prevent the foam from uniformly contacting the drywall and should be avoided.

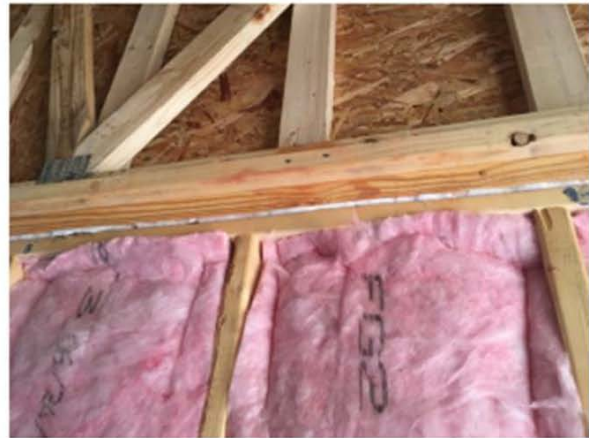
An example of foam applied at the seam of top plates.
